PROJECT SHEET

VILUFUSHI, MALDIVES

DREDGING, RECLAMATION, RECONSTRUCTION AND ENVIRONMENTAL MONITORING WORKS

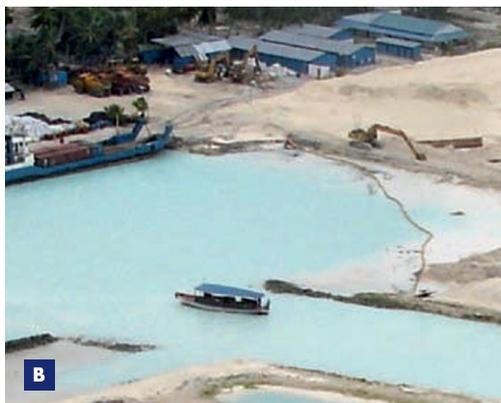
- A** View of the dredging activities at Vilufushi, with the cutter suction dredger Ursa at work pumping sand directly to the area to be filled.
- B** Silt screen deployed in the old harbor basin around the discharge point. The monitoring vessel is in the center of the photo
- C** Coral and other marine life in the vicinity of Vilufushi
- D** After the tsunami struck the surviving population was evacuated to the nearby island of Buruni.
- E** A dhoni (local type of boat) was fitted out specially as a monitoring vessel. It was equipped with a multitude of high-tech devices
