PROJECT SHEET

ENVIRONMENTAL MONITORING DAYA BAY
DREDGING APPROACHES NANHAI PETROCHEMICALS PROJECT

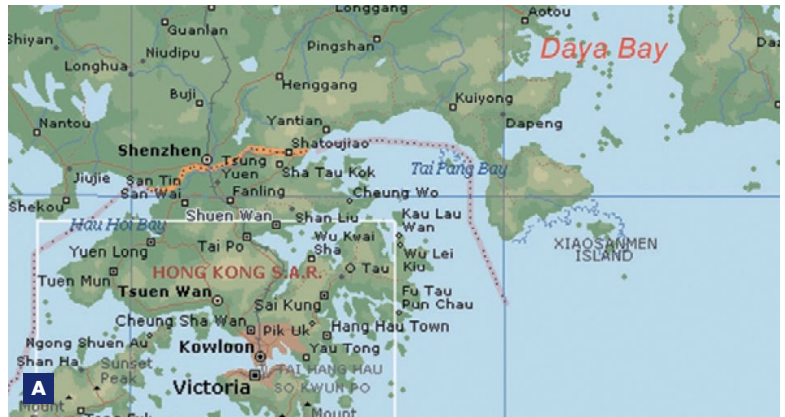
- A Location map
- B Visual inspection of coral
- C TSHD 'Queen of the Netherlands' dredging in Daya Bay

Once per week a team of scuba divers collected the trapped sediment and the average sedimentation rate per day was determined. At the same time the diving team captured movie-shots of the corals which were used to visually establish sedimentation on the coral.

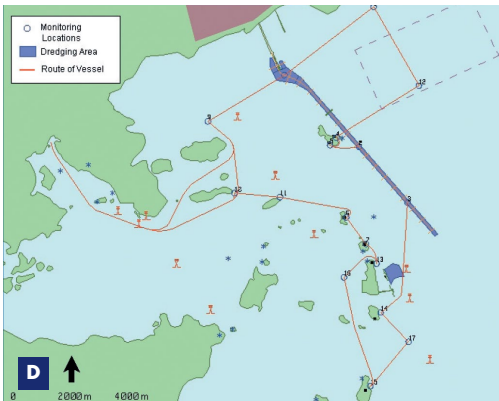
- D** Monitoring locations
- E** Logging system onboard monitoring vessel
- F** Scuba diver with sediment trap
- G** Monitoring vessel 'Yangpingji 88'

During the execution of the dredging works water quality monitoring was carried out at 17 locations around Daya Bay. At these locations turbidity, dissolved oxygen (DO), salinity and temperature was monitored with direct-reading-instrument YSI on a daily basis. Current velocity and direction were measured by ADCP (Acoustic Doppler Current Profiler) at the same time. During the first phase of monitoring, water samples were taken frequently and analysed for SSC, to establish the relation between SSC and turbidity. The monitoring devices were operated from a purpose-built frame mounted on deck of the monitoring vessel 'Yangpingji 88'. All collected data was stored on the monitoring computers on board the vessel and postprocessed in the site office at the end of the day for daily reporting to the Client. Another important element of the monitoring plan included sedimentation rate monitoring at coral sites. At 7 locations where coral is present, sediment traps had been installed.
