PROJECT SHEET

SWINOUJSCIE, POLAND

CONSTRUCTION OF PROTECTIVE BREAKWATER AND ACCESS CHANNEL FOR SWINOUJSCIE EXTERNAL PORT

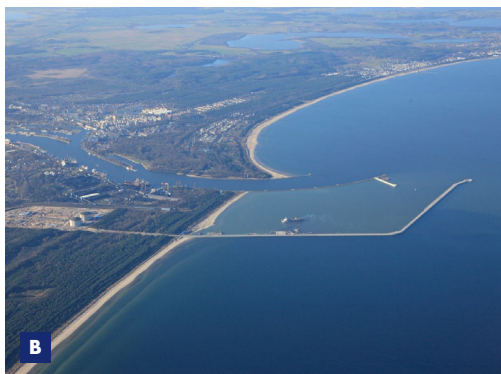
B Aerial view November 2012

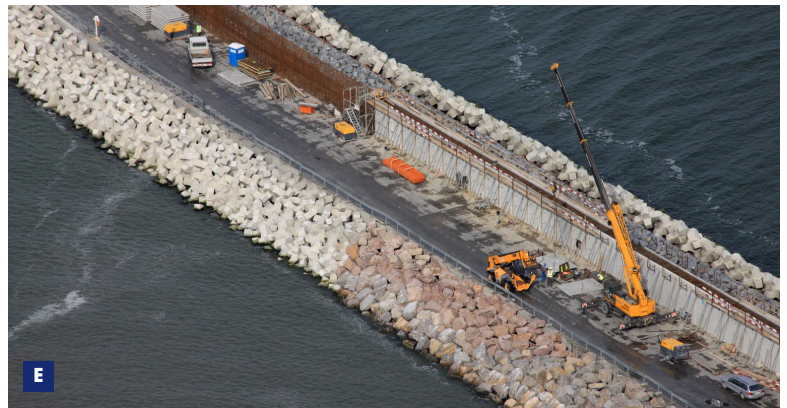
- D** Aerial view February 2012 showing spud pontoon and rock barge
- E** Aerial view showing parapet wall under construction, Xbloc and armor rock construction
- F** Roundhead under construction, civil works, rock profiling, Xbloc placement

The main structure was built and shaped by excavators operating on the core structure or from spud pontoons. The excavators were equipped with a crane monitoring system (CMS) developed in house and based on DGPS, allowing for the rapid and precise shaping of the rock layers above and below the water level.
