# PROJECT SHEET

**MUUGA COAL TERMINAL**  
ESTONIA

## GENERAL INFORMATION

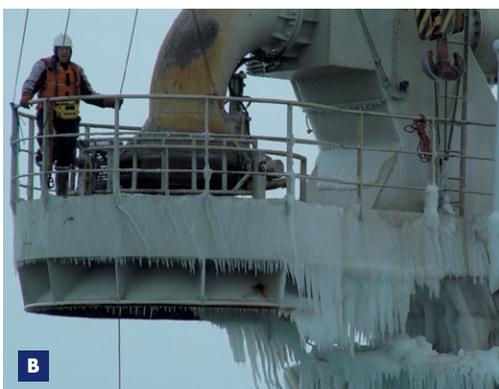
- A Location map
- B Heavy ice on deck of TSHD Coastway
- C The completed coal terminal

Weather and, in particular, winter ice conditions have been a challenge. The water has a low salinity and heavy ice soon built up on deck of the

dredgers. A thick coating of ice made working conditions very uncomfortable. The project's design also took account of a series of strict environmental parameters. The coastline in this area was out of bounds to the public during Soviet times. For this reason habitats controlled by the military were left undisturbed. They are now recognized as valuable wildlife reserves and, as such, are subject to strict supervision and protection. There was also another challenge: unexploded ordnance. It was estimated that around 80,000 sea mines were sown in the Gulf of Finland. When dredging began the dredgers were always preceded by a minesweeper. Estonian Navy mine experts were in residence on board each trailer. Every hopper of sand brought to the site was checked by military personnel. Some 1,200 items of unexploded ordnance have been recovered and safely disposed of.

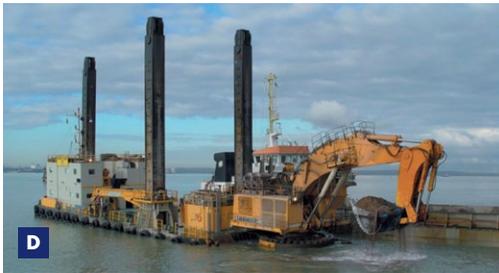
- D** Backhoe Nordic Giant
- E** TSHD Seaway pumping ashore
- F** Reclamation works by TSHD Coastway
- G** Installation of vertical drains
